**REQUEST FOR PROPOSALS FOR
ASBESTOS ABATEMENT AND DEMOLITION IN MERCEDES POLICE DEPARTMENT**

ASBESTOS ABATEMENT SPECIFICATION

Mercedes Police Department Building
316 South Ohio Avenue
Mercedes, Texas 78570

Terracon Project Number: 88217263

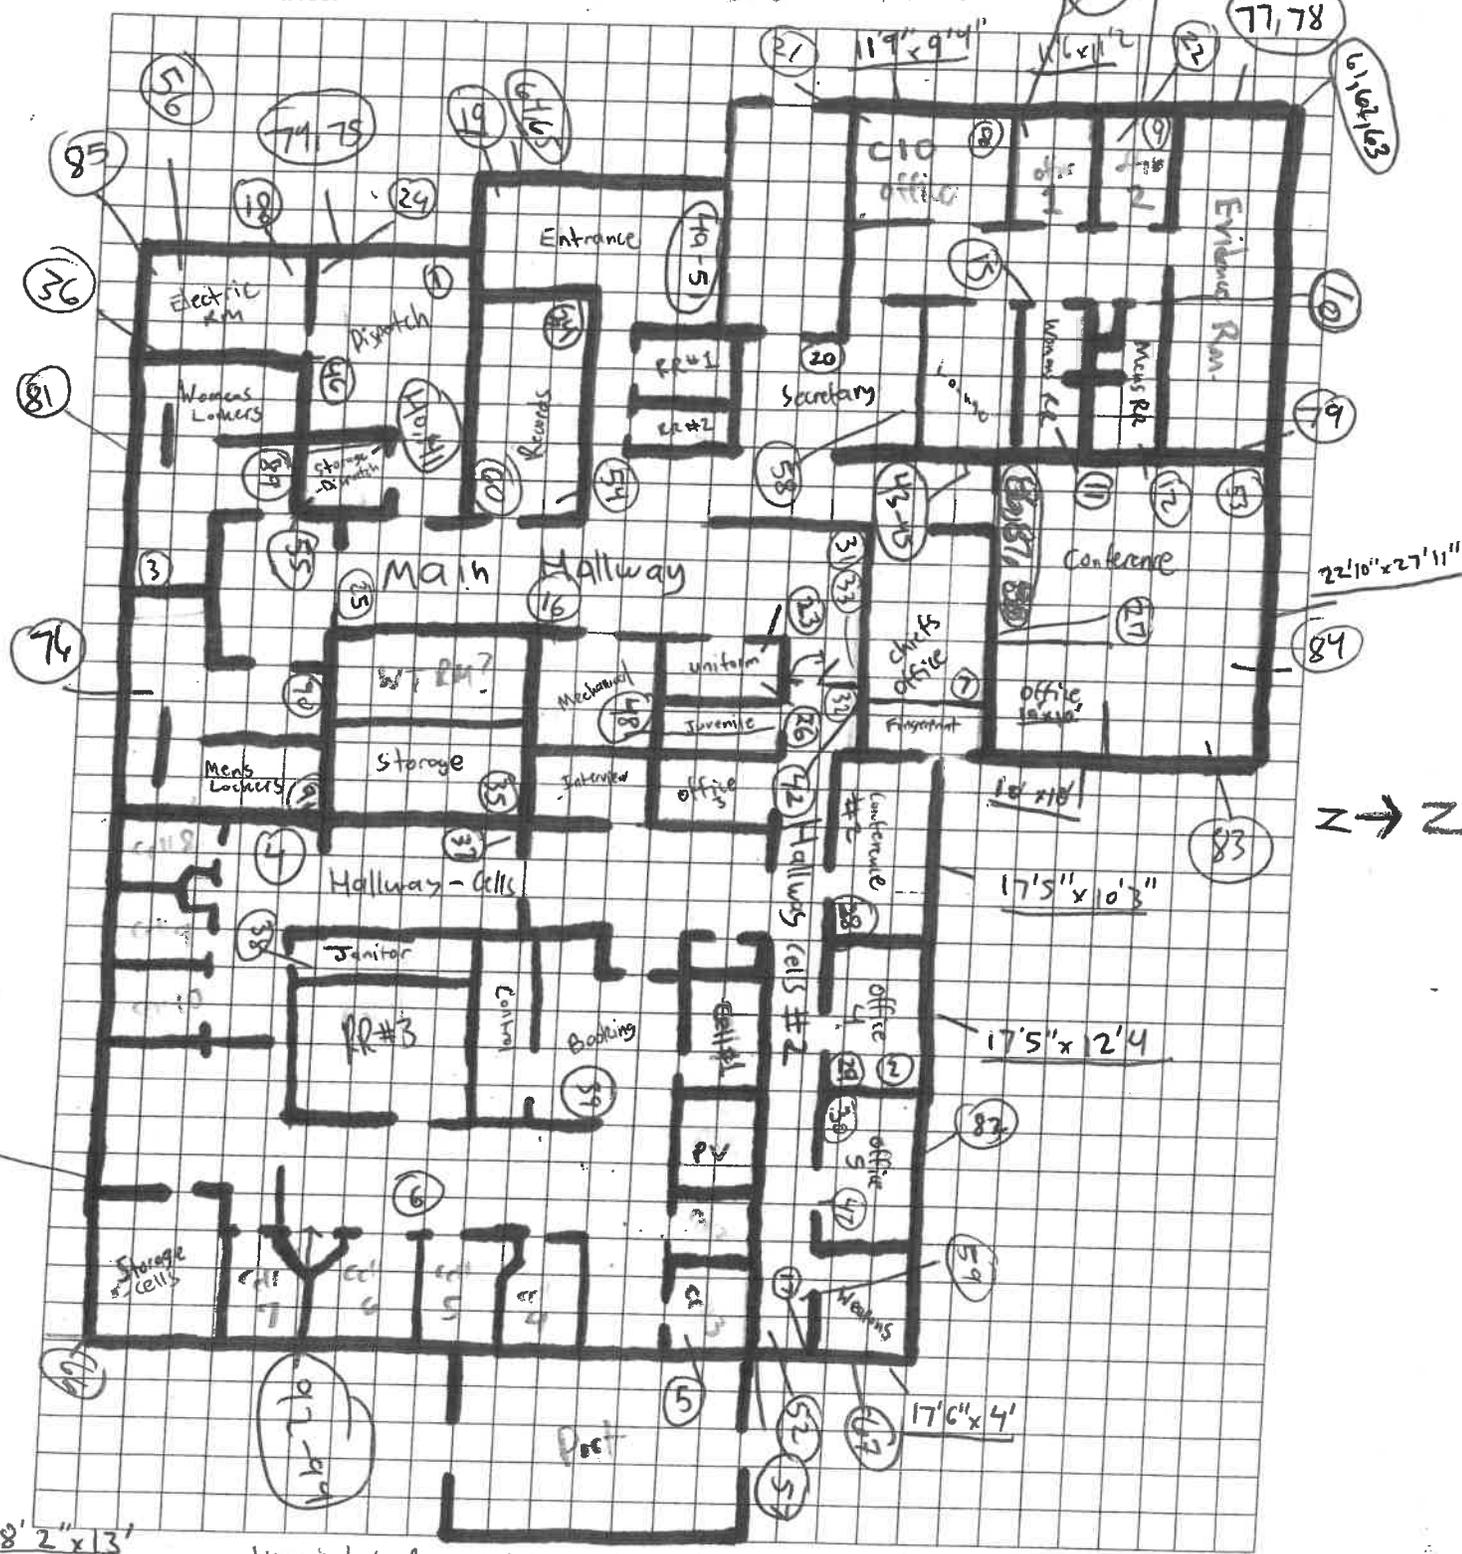
Entrance: 28'2" x 13'
 #1: RR#2: 8'2" x 5'10"
 #2: 15'4" x 19'8"
 #3: Dispatch: 6'8" x 9'8"
 #4: 21'10" x 16'1"

Women's Locker Room: 19'11" x 17'7"
 Mens Locker Room: 19'11" x 17'7"
 Storage: 21'10" x 13'1"
 Uniform: 11'1" x 11'2"
 Office #3: 9'3" x 7'7"
 Interview: 17' x 10'11"
